# 2016 ANNUAL WASTEWATER TREATMENT SYSTEM SUMMARY REPORT **Drumbo Wastewater Treatment Plant**

# 2016 ANNUAL WASTEWATER TREATMENT SYSTEM SUMMARY REPORT **Ingersoll Wastewater Treatment Plant**

# 2016 ANNUAL WASTEWATER TREATMENT SYSTEM SUMMARY REPORT Woodstock Wastewater Treatment Plant

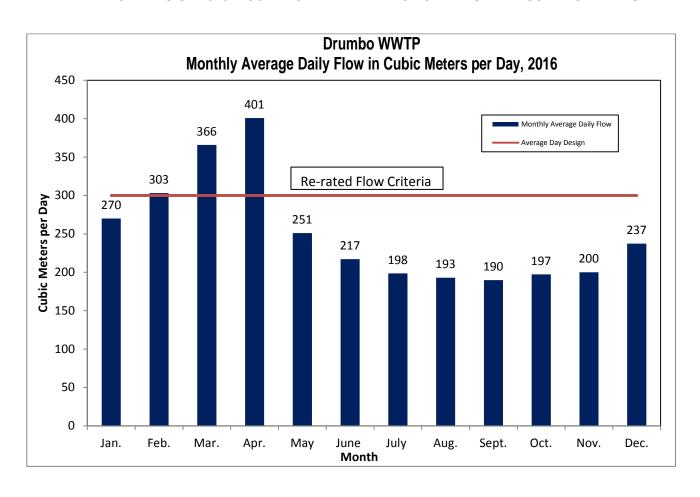
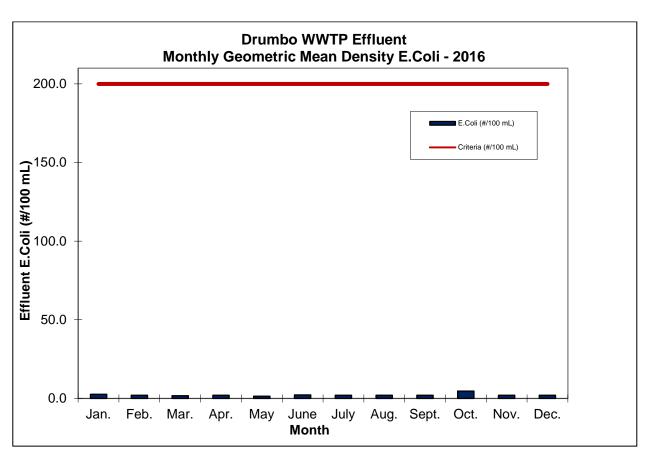
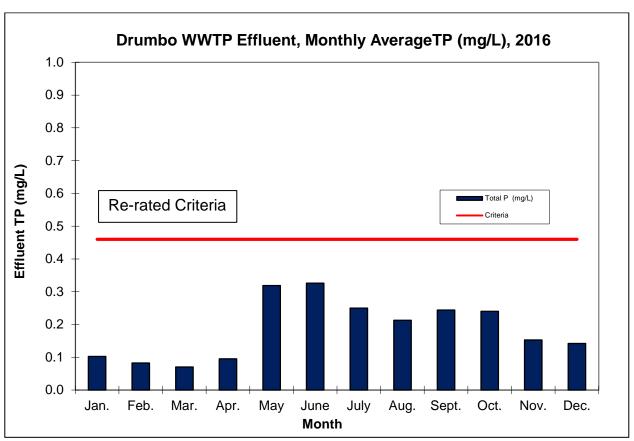
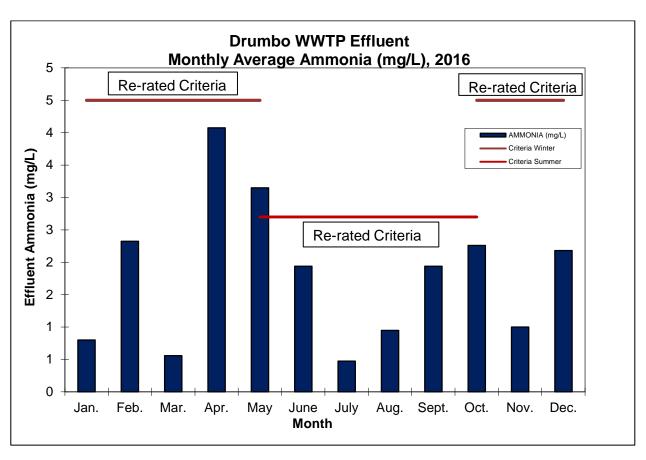
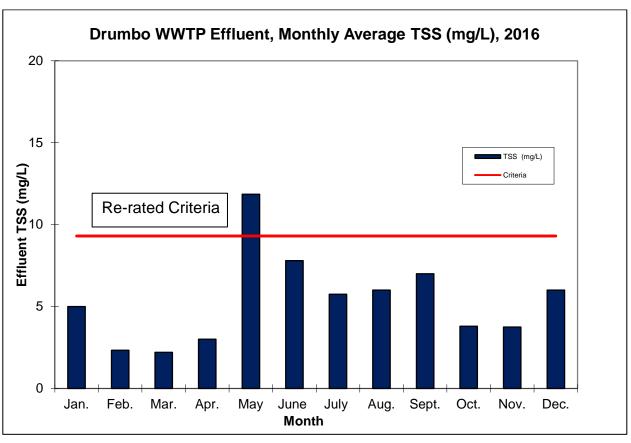
## APPENDIX A: GRAPHS OF 2016 DISCHARGE PARAMETERS VS. EFFLUENT DISCHARGE LIMITS

Graphs of discharge parameters versus effluent discharge limits are included in this report in Appendix A. Influent wastewater characteristics and effluent discharge values are presented in the tables below.
